**FINAL RCRA SITE VISIT REPORT**

**Precision Products Group, Inc. – Stone Industrial Division  
EPA ID No. MDD 058 594 920  
9207 51<sup>st</sup> Avenue  
College Park, MD 20740**

**SUBJECT: FINAL RCRA CORRECTIVE ACTION SITE VISIT REPORT  
USACE CONTRACT NO. W912DQ-08-D-0019  
TASK ORDER NO. 005A**

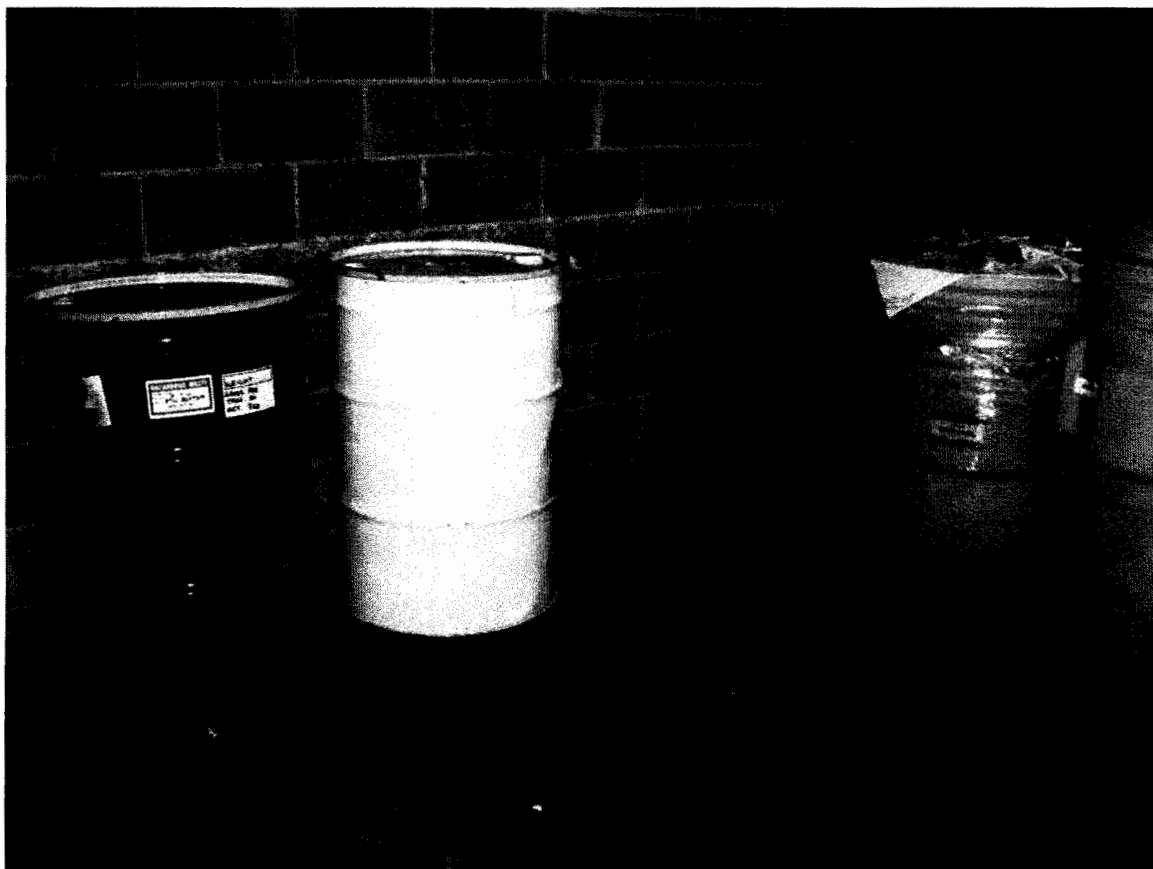
The adhesive used to bind plastic wound tubing was temporarily stored adjacent to the winding machines in the Plastic Winding Building. The adhesive was recycled at the rear of the building where solvents were recovered through a 2-day distillation process. Drums were historically staged on the concrete floor of this area. Evidence of minor spills and over fills (interior of the building) was noted in the October 1989 Environmental Priorities Initiative - Preliminary Assessment Report. Photograph No. 1 shows this unit.

View of SWMU No. 1 – Former Flammable Spent Solvents Satellite Storage in the Plastic Winding Area of Building 2

No evidence of any other spills or releases was found during the site visit or in the files reviewed at the MDE or USEPA Region III offices. Site representatives are unaware of any additional spills or releases from this unit, and had no information regarding any spills or releases in their files.

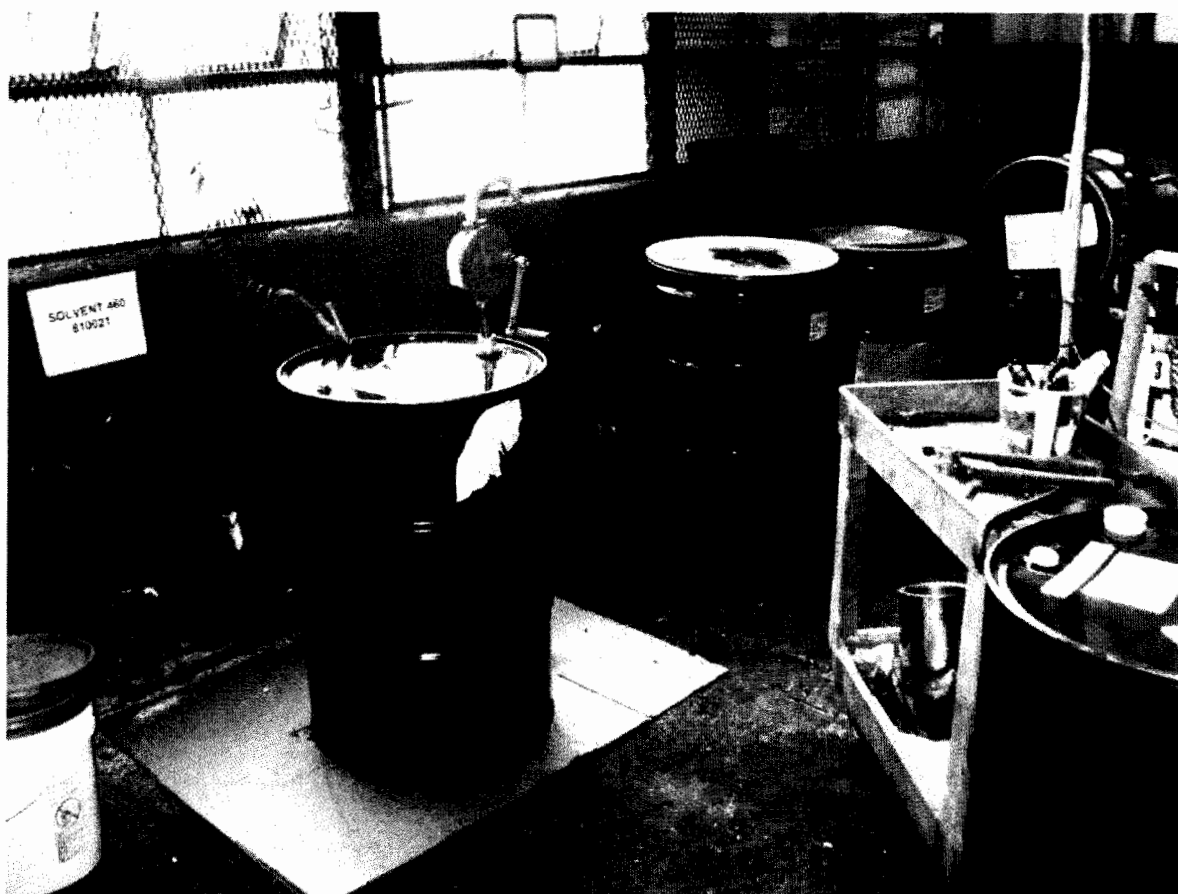
The Current Satellite Storage Area is located in the Chemical Room of the Plastic Winding Building. This area is used to store a variety of chemicals including pressure sensitive adhesive, polyester adhesive, isopropyl alcohol, toluene, and acetone. This unit has a concrete floor. Photograph No. 2 depicts this unit.

Filled drums of ignitable still bottom and waste polyester resin bag liners are stored in metal racks.

View of SWMU No. 2 – Current Satellite Storage Area located along the Interior Northern Wall of Building 2

No evidence of a spill or release was found during the site visit or in the files reviewed at the MDE or USEPA Region III offices. Site representatives are unaware of any spills or releases from this unit, and had no information regarding any spills or releases in their files.

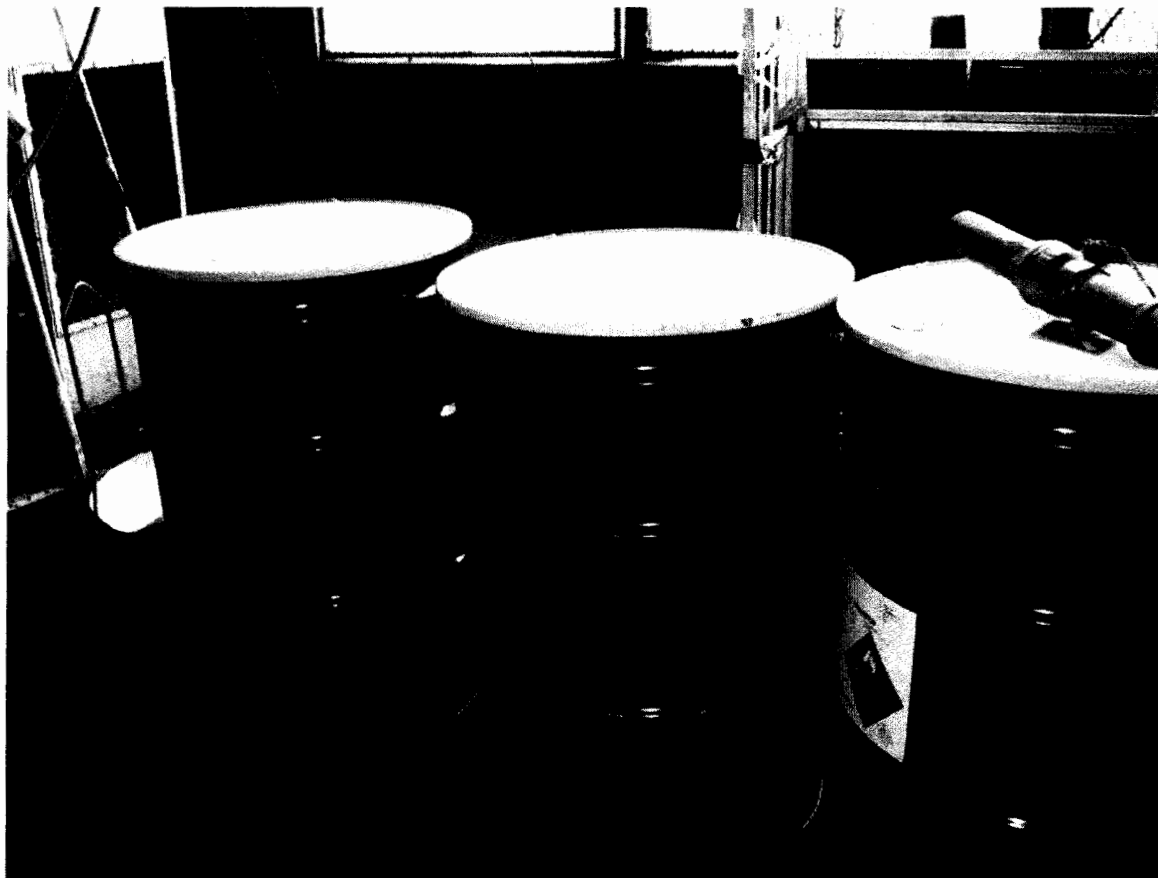
The facility currently operates two solvent distillers to recover solvents from the spent solvent adhesive used to bind the plastic wound tubing. The units have been in use since approximately 1992 and are 55-gallons in size. These units are shown in Photograph No. 4.

View of SWMU No. 4 – Current Recovered Solvent Distiller Along Interior Northern Wall of Building 2

No evidence of a spill or release was found during the site visit or in the files reviewed at the MDE or USEPA Region III offices. Site representatives are unaware of any spills or releases from this unit, and had no information regarding any spills or releases in their files.

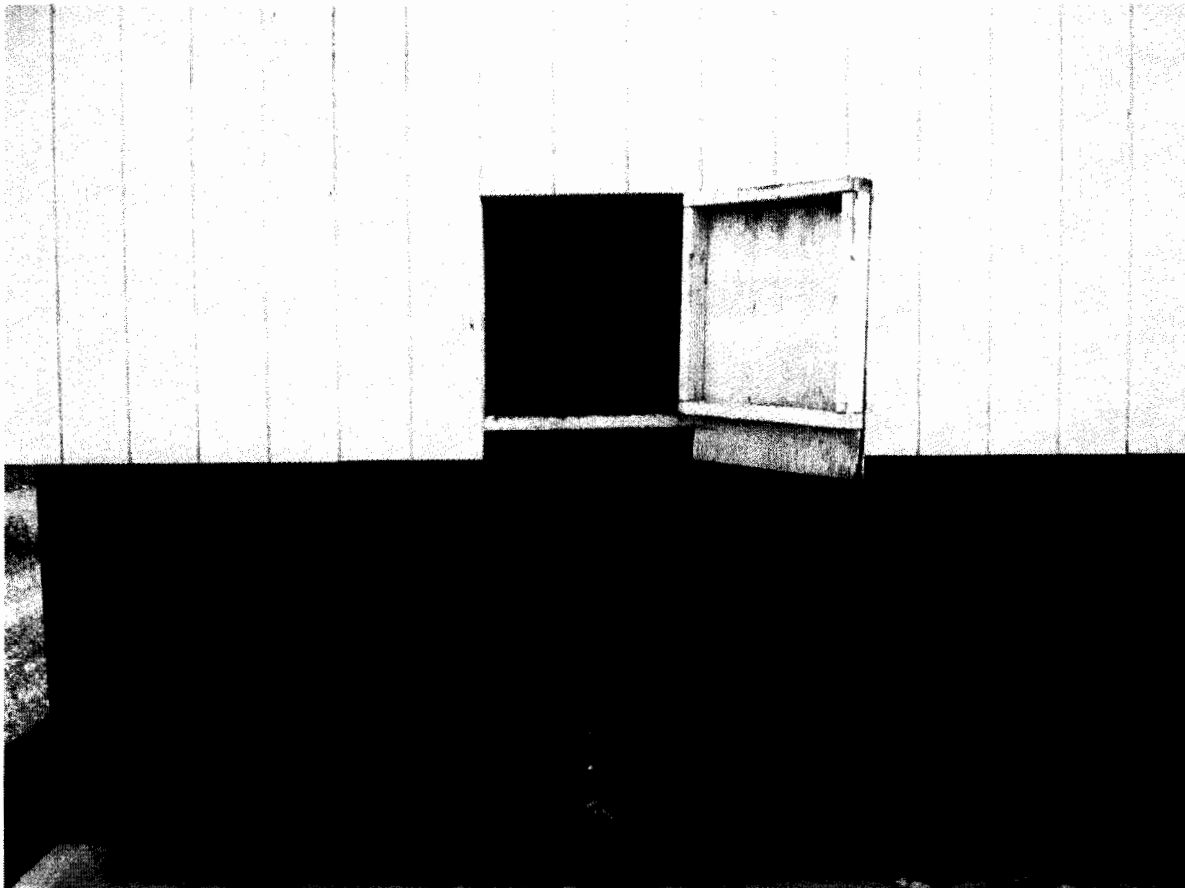
A 6,000-gallon self-contained Aboveground Storage Tank (AST) is used to store wastewater generated by the former wet grinding portion of the phenolic paper impregnation process. The high pH non-hazardous wastewater is removed from the tank twice per year by DuPont for offsite treatment and disposal. This tank replaced a wastewater UST (located near the former MEK UST location) in 1989. Lye used to clean equipment was also directed to the UST. This unit is shown in Photograph No. 5.

View of SWMU No. 5 – Wastewater Aboveground Storage Tank at Northern Exterior of Building 2

No evidence of a spill or release was found during the site visit or in the files reviewed at the MDE or USEPA Region III offices. Site representatives are unaware of any spills or releases from this unit, and had no information regarding any spills or releases in their files.

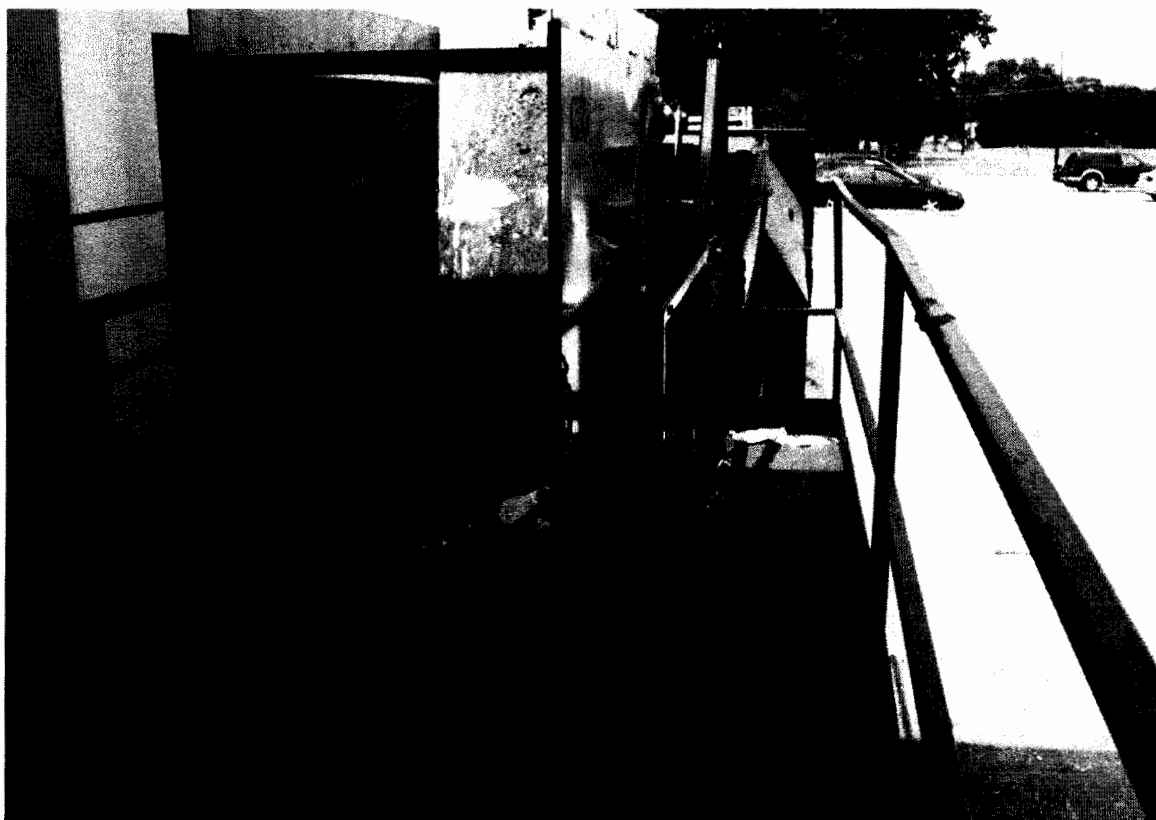
One trash compactor is in use near the main entrance of building (middle of western side of building). The trash compactor is located near a blind sump; liquid from this sump is transferred to SWMU No. 5. An area beneath the portion of the trash compactor closest to the building was observed to be stained with oil during the June 22, 2010 Site Visit. Photograph Nos. 6 and 7 show this unit.

View of SWMU No. 6 – Trash Compactor at Entrance to Building 2

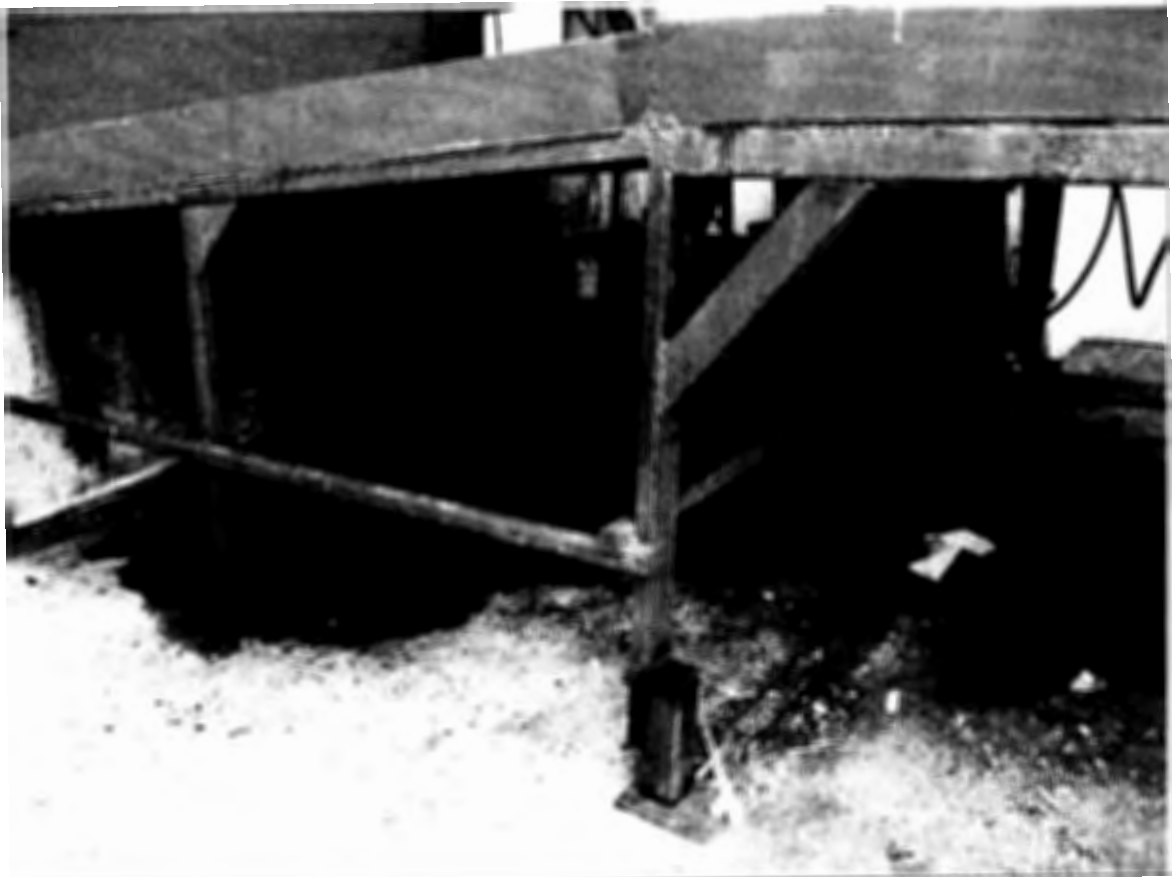
View of Staining Beneath SWMU No. 6 – Trash Compactor at Entrance to Building 2

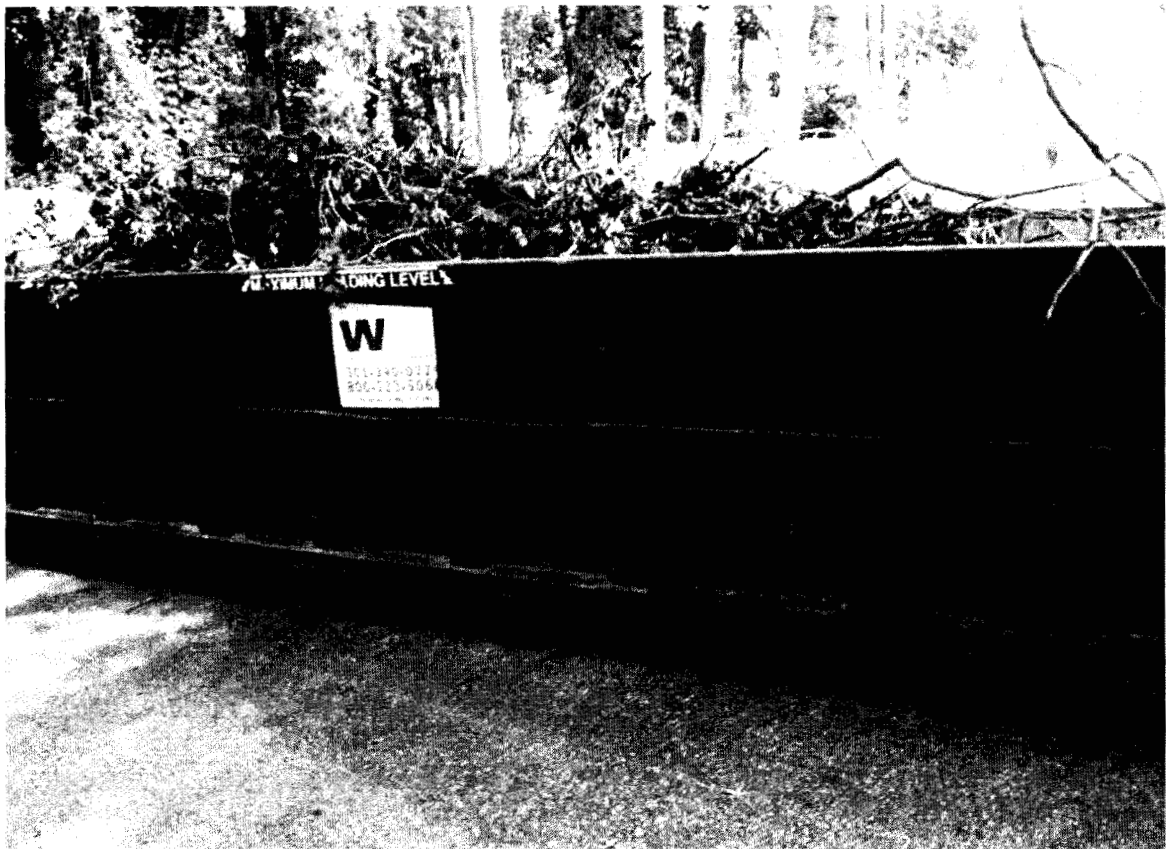
Two trash dumpsters were observed on the southern side of the site during the June 22, 2010 Site Visit. They were found to contain general trash and landscaping debris (branches, tree limbs, etc) as shown on Photograph No. 8. Site representatives indicated that typically one dumpster is used onsite.

View of SWMU No. 7 – Trash Dumpsters Located in the Parking Lot South of the Administrative Building

No evidence of a spill or release was found during the site visit or in the files reviewed at the MDE or USEPA Region III offices. Site representatives are unaware of any spills or releases from this unit, and had no information regarding any spills or releases in their files.

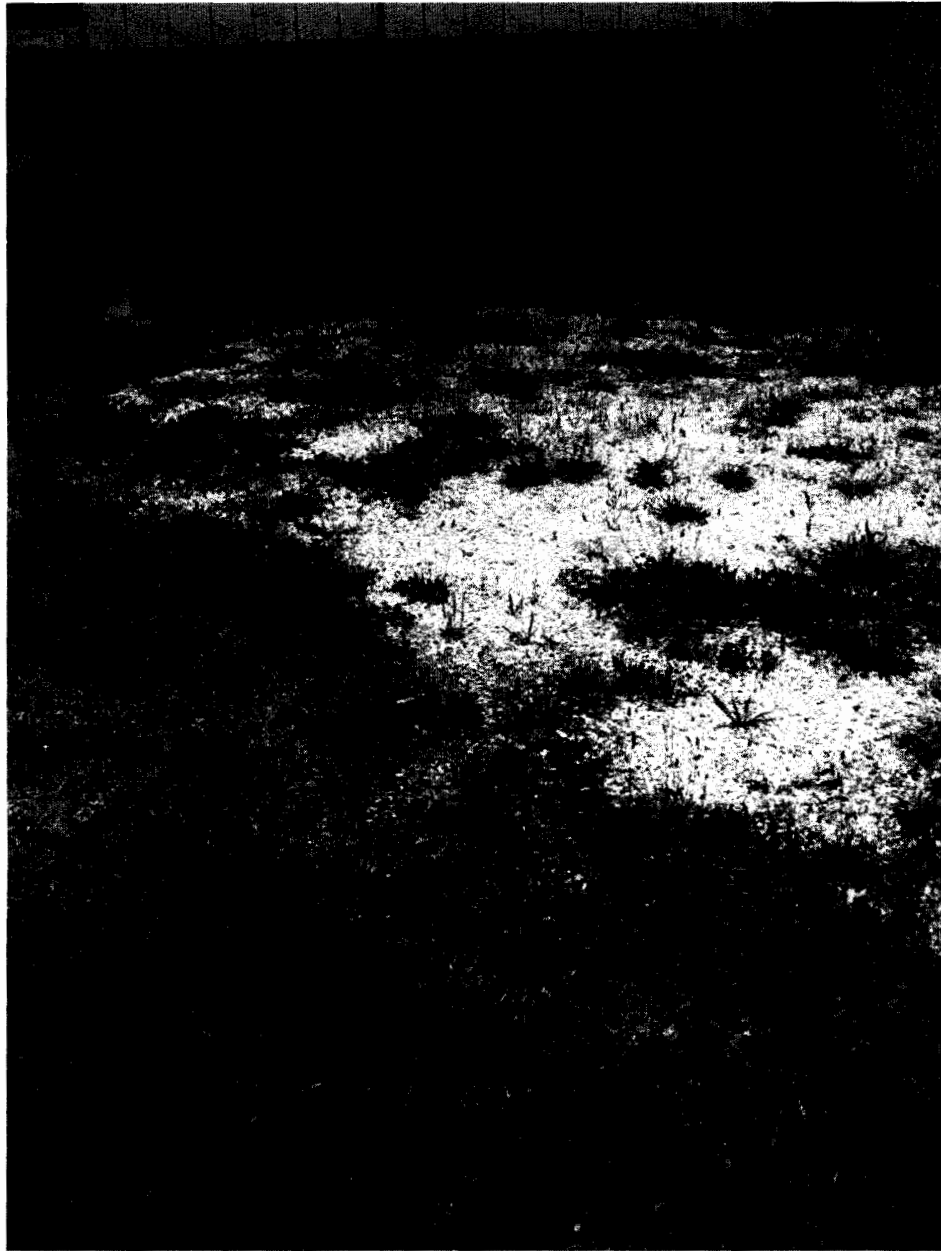
On August 22, 1989, an MEK UST system was overfilled, resulting in the release of approximately 450 gallons of product. This tank system was comprised of two USTs; Tank Nos. 2 and 3, which were each 750 gallons in capacity and connected by piping (the facility referred to this as one UST when discussing the release). This tank was located near the northwestern corner of the Paper Winding Building as shown on Photograph No. 9. According to an October 9, 1989 from the facility to the MDE, the release was reported to the National Response Center (NRC) within an hour of being identified.

The spill migrated approximately 10 feet towards the adjoining College Park Public Works property. The MEK flowed 290 feet northeast across the Public Works property turning south on to the CSX Transportation property, flowing an additional 15 to 20 feet. The spill was contained and cleaned up under the oversight of a Public Health Engineer from the Maryland Hazardous and Solid Waste Management Administration section of the MDE.

On August 23, 1989, EA Engineering, Science, and Technologies (EA) collected twelve soil samples along the path of the spill. Soil sample results ranged from trace amounts (at furthest point from the spill site) of MEK to 12,000 parts per million (ppm) (at the spill site). On September 1, 1989, a representative of the MDE's Underground Storage Tank (UST) Division inspected the site (the project was transferred from MDE's Hazardous and Solid Waste Management Enforcement Division to the UST Division). This representative explained that all area except along the railroad fence line could be backfilled (the excavation that took place before this inspection was not described in this document). The area along the fence line between the Public Works property and the CSX railroad required further excavation.

View of AOC 1 – Methyl Ethyl Ketone Release West of Building 2

Further excavation was conducted on September 27, 1989 once access to CSX property was obtained in the presence of the UST Division representative. During the excavation activities, EA collected volatile readings with a hand held meter; the soil was excavated to a depth when these readings became acceptable to the UST Division representative (0 to 2 parts per billion (ppb)). A total of 157 metal 55-gallon drums of soil had been removed from the excavation. The drums were shipped to ChemWaste Management, Inc. in Emelle, Alabama.

- Return all disturbed areas to the original and acceptable condition of the owners (completed)
- Submit copies of soil sample results (completed)
- Submit copies of hazardous waste manifests upon disposal (completed)

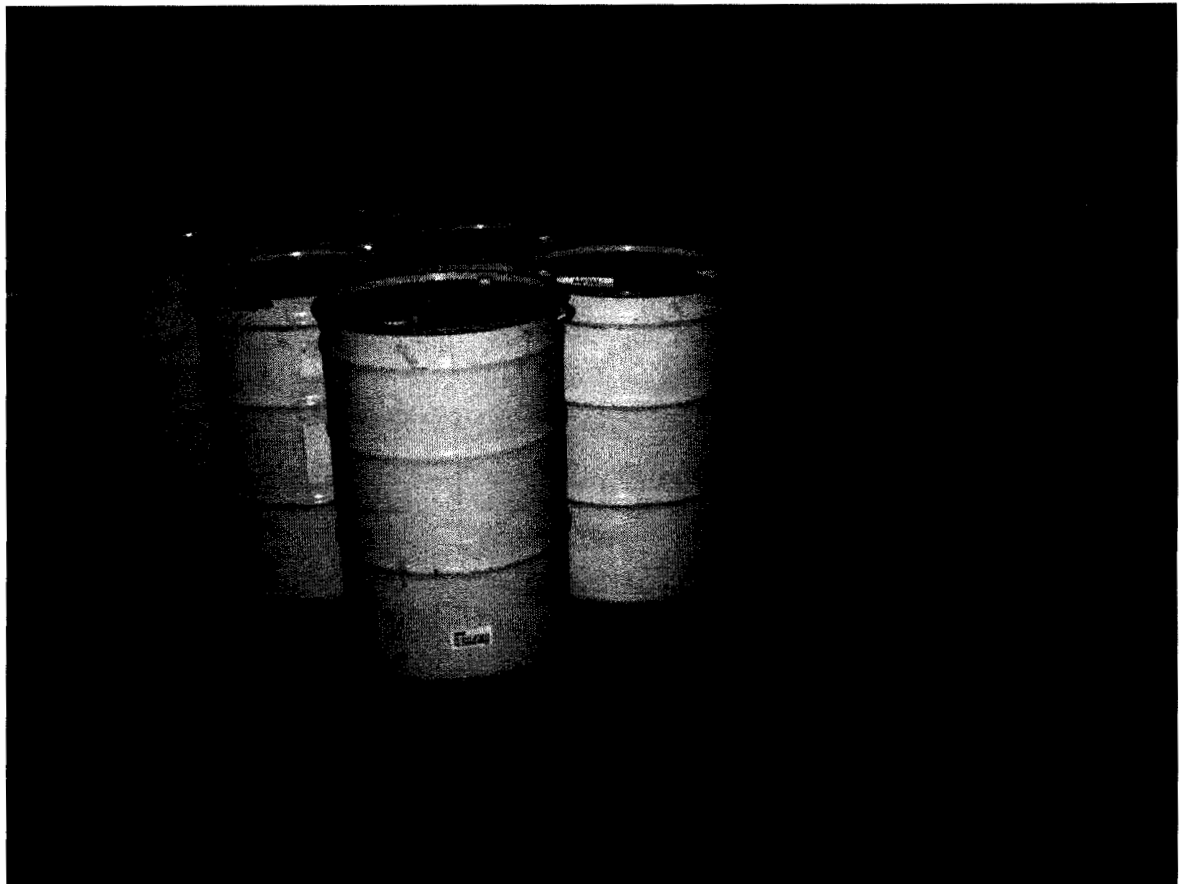
View of Production Raw Material Storage Area
